# Pro-Tech Property Inspection Inc.

## SUMMARY REPORT

**Client:** Dora Osuna  
**Inspection Address:** 15660 Citron Ave., Fontana, CA  
**Inspection Date:** 11/5/2010 Start: 9:00 am End: 11:30 am  
**Inspected by:** Ryan Penn

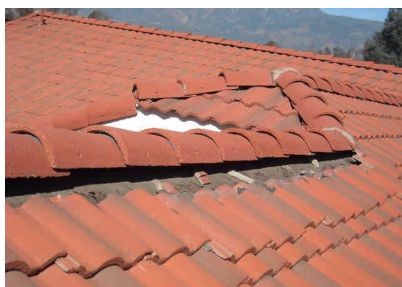
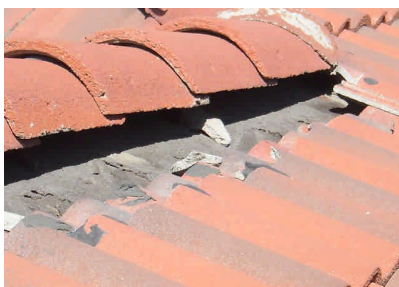
The roof needs to be serviced for the following reasons: There are several tiles that have come out of place in various locations which has exposed the underlayment and caused it to become deteriorated and in need of repairs. This service should be scheduled well before the close of escrow, because additional defects could be revealed by a specialist, and our service does not include any guarantee against leaks. For a guarantee, a roofing company would have to perform a water-test and issue a roof certification.
